**Maryland Transit Administration**

**Multi-Media Inspection Report**

**1515 Washington Boulevard**

**Maryland Transit Administration Bus Facility**  
**1515 Washington Blvd.**  
**Baltimore, Maryland**

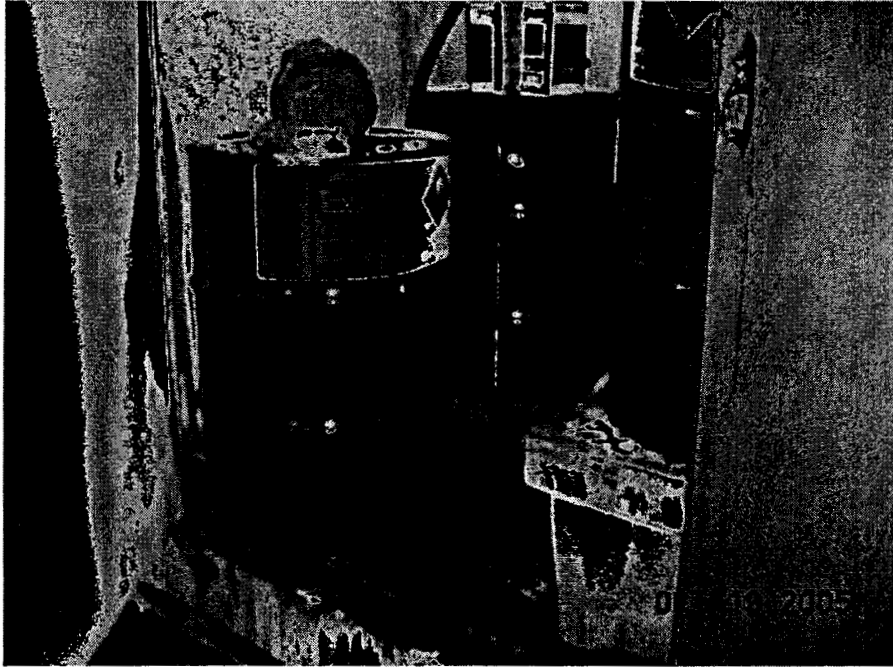
454

This container was located in the flammable storage shed, it held waste from the paint booths. The container was closed, but not dated or labeled as a hazardous waste. No leaks were observed.

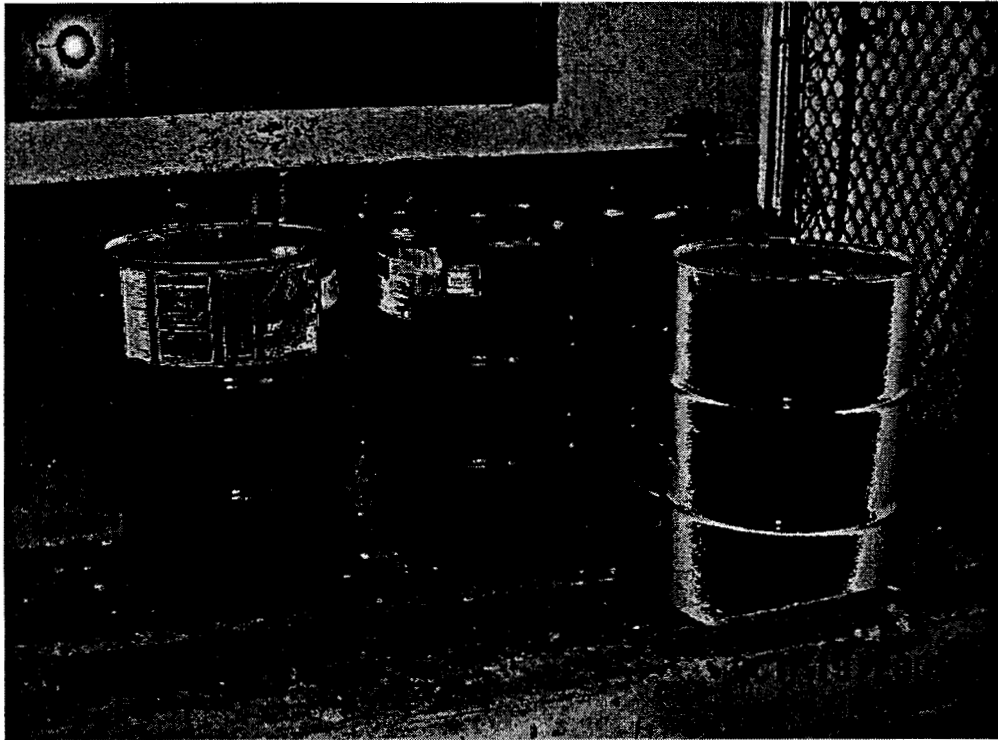
The storage cage was labeled for hazardous waste storage and was surrounded by a chain link fence and lockable gate. It also had secondary containment and a fire extinguisher was present. Four drums were observed (**photos #455 & 456**). All of the drums were completely full. Other than their original label, none of the containers were labeled with the words hazardous waste or dated with an accumulation start date. One container was open. According to the facility, all the containers held waste from their process. Someone had written 'full' on the containers. There was some confusion concerning the contents and origin of three of the drums. According to facility representatives, the day before the inspection only one drum of waste paint thinner was stored. Then three additional drums showed up in the storage area. One of the body shop representatives thought they originated from the print shop since the product labels on the drums were consistent with product used in the print shop. According to the print shop manager, Tony Lisby, he does not generate drum quantity waste. The material originally in the containers is used to wash the blankets, rollers, etc. from the printers, but it evaporates quickly and is never placed into drums. According to the facility, inspections are not conducted at either of the facility's hazardous waste storage areas.

This cage was labeled for hazardous waste storage and surrounded by a chain link fence and lockable gate. It also had secondary containment and a fire extinguisher was present. Four drums were observed (photo 455 & 456). All were full. Other than their original label, none of the containers were labeled with the words hazardous waste or dated with an accumulation start date. One container was open. According the facility, all the containers held waste from their process. Some one had written 'full' on the containers. There was some confusion concerning the contents of three of the drums. Yesterday, one drum of waste paint thinner was stored. Then three additional drums showed up. One of the body shop representatives thought they originated from the print shop since the product labels were consistent with the print shop. According to print shop leader, Tony Lisby, he does not generate drum quantity waste. The material originally in the containers is used to wash the blankets, rollers, etc. from the printers, but it evaporates quickly. According to the facility, inspections are not conducted at either of the hazardous waste storage areas.

These four drums of waste were located in the storage cage. According to the facility, they are waste for disposal. The containers were not labeled or dated. All were closed except for the white drum. There was some confusion where three of the drums originated. Secondary containment is also provided..

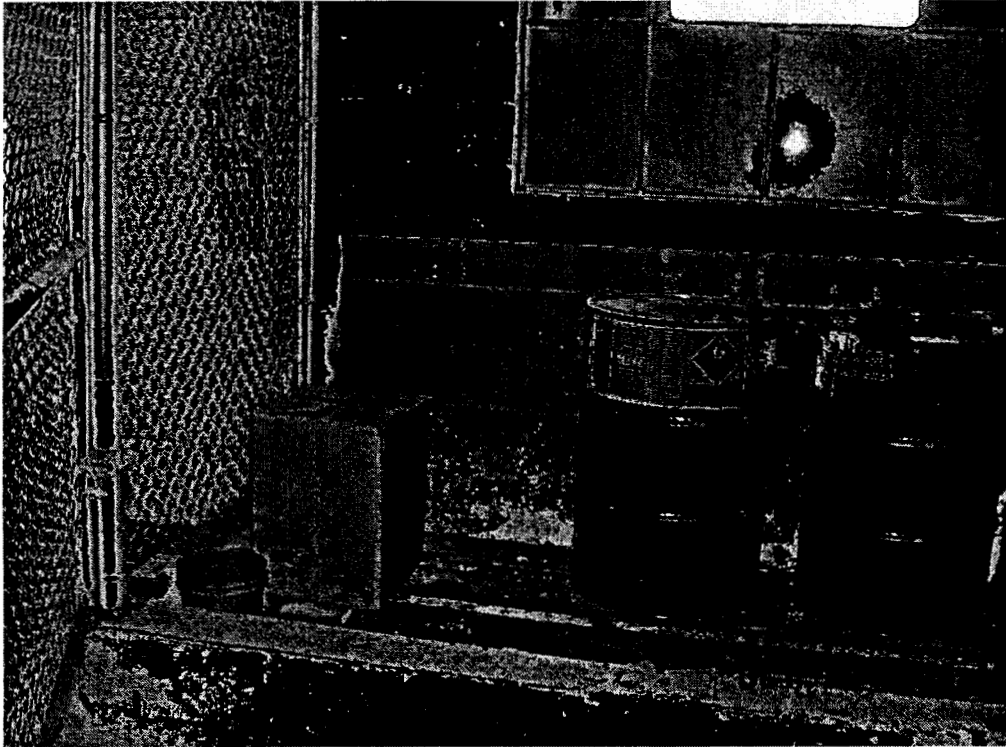
456

Also observed in the storage cage, were two boxes containing Universal Waste (**photo # 456**). One box was labeled "mercury in lamps arc tubes" the other was labeled "NICAD Batteries". The containers were closed but not dated. The wording on the containers did not follow exactly the wording required by the regulation. The facility also had a large number of lead batteries stored onsite (**photo #477**). Facility personnel explained that the batteries were recycled and that they were overdue for a pick-up.

Also observed in the storage cage, were two boxes containing Universal Waste (photo 456). One box was labeled "mercury in lamps arc tubes" the other was labeled "NICAD Batteries". The containers were closed but not dated. The wording on the containers did not follow exactly the wording required by the regulation.

The two boxes contained Universal waste. The larger box was labeled "mercury in lamps arc tubes" the smaller box was labeled "NICD Batteries". The box labeling did not conform the Universal waste rules and the they were not dated.

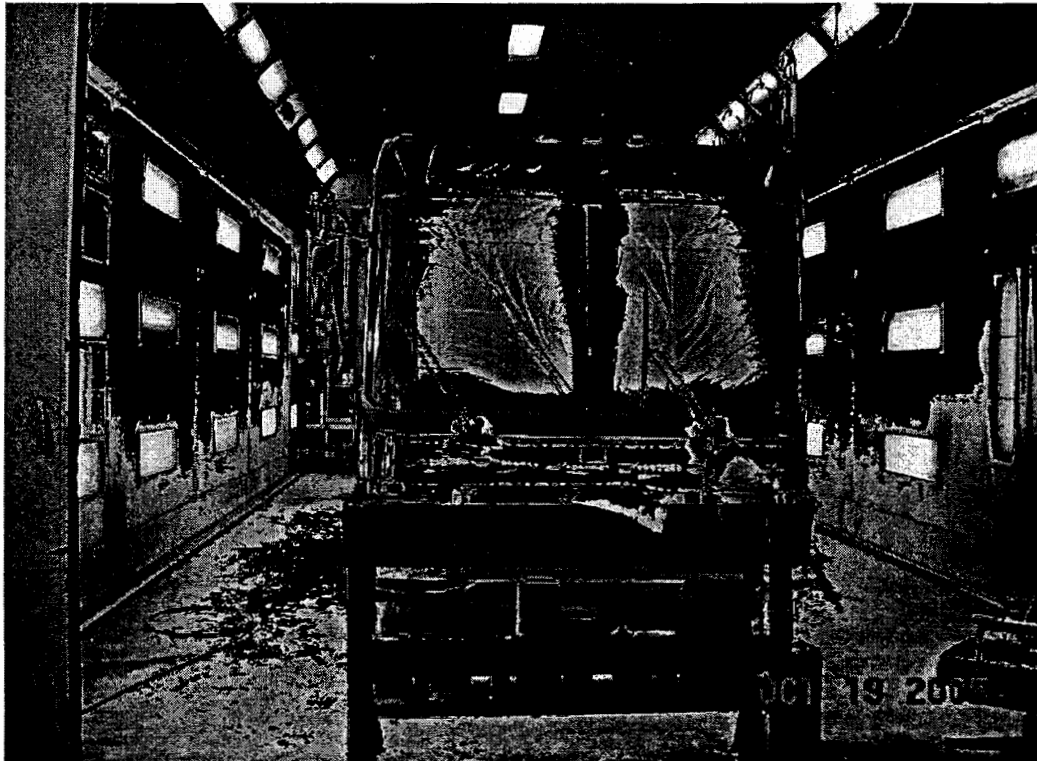
458

Lower paint booth with a freshly painted bus.

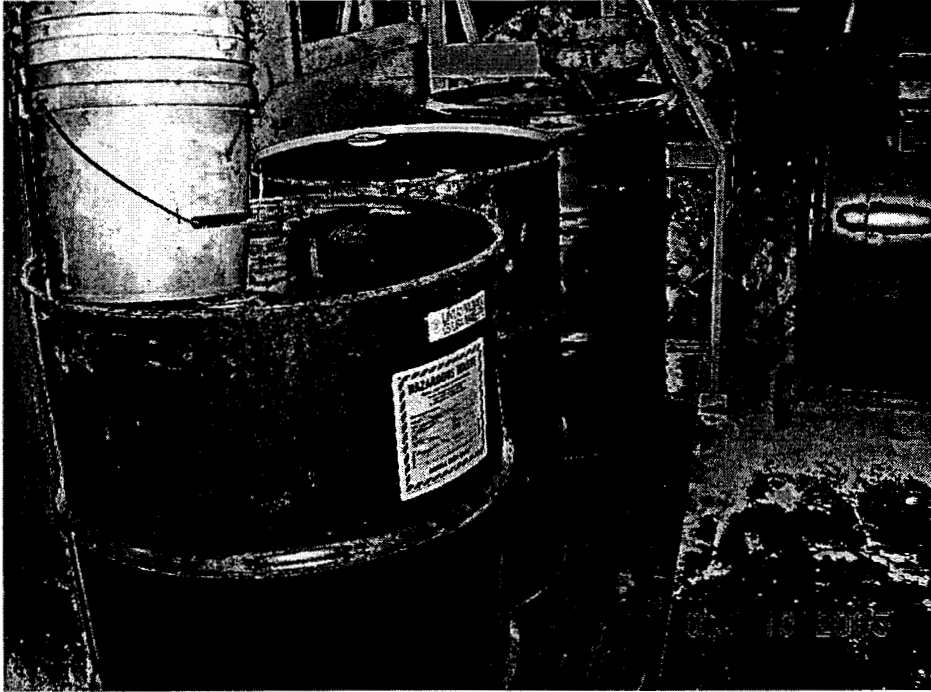
459

The air condition shop generates a waste-compressor oil contaminated with Freon 22. It is managed as a hazardous waste by shop personnel. The shop representative was Paul Sanders. Three drums were observed in the storage area (**photo #459**). The center drum was empty. The drum in the foreground was full and labeled. The writing had smeared and it was hard to read. It was not dated. The third drum was about 1/4 full. It was neither labeled or dated. This container was also open with a funnel in the large bung hole. It was closed immediately when the EPA inspectors mentioned that it was not properly closed. Secondary containment was also provided. No inspections were conducted of this storage area.

The air condition shop generates a waste compressor oil contaminated with Freon 22. It is managed as a hazardous waste. The shop representative was Paul Sannders. Three drums were observed (Photo 459). The center drum was empty. The drum in the foreground was full and labeled. The writing had smeared and it was hard to read. It was not dated. The third drum was about 1/4 full. It was neither labeled or dated. This container was also open with a funnel in the large bung hole. It was closed immediately. Secondary containment was also provided. No inspections were conducted of the storage area.

AC Shop, this is the accumulation area for waste compressor oil contaminated with Freon 22. The container in the foreground is full and labeled but not dated. The center drum is empty. The container in the background was about 1/4 full, not dated or labeled for content. Secondary containment is provided.

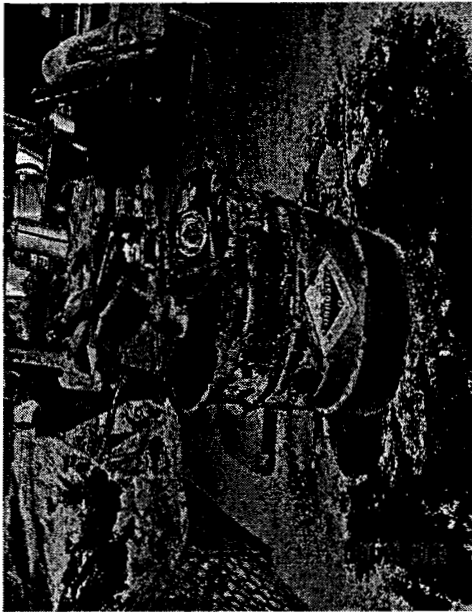
460

Agitation parts cleaner, the solvent used in this container is a hazardous waste when disposed. Safety-Kleen manages the waste.

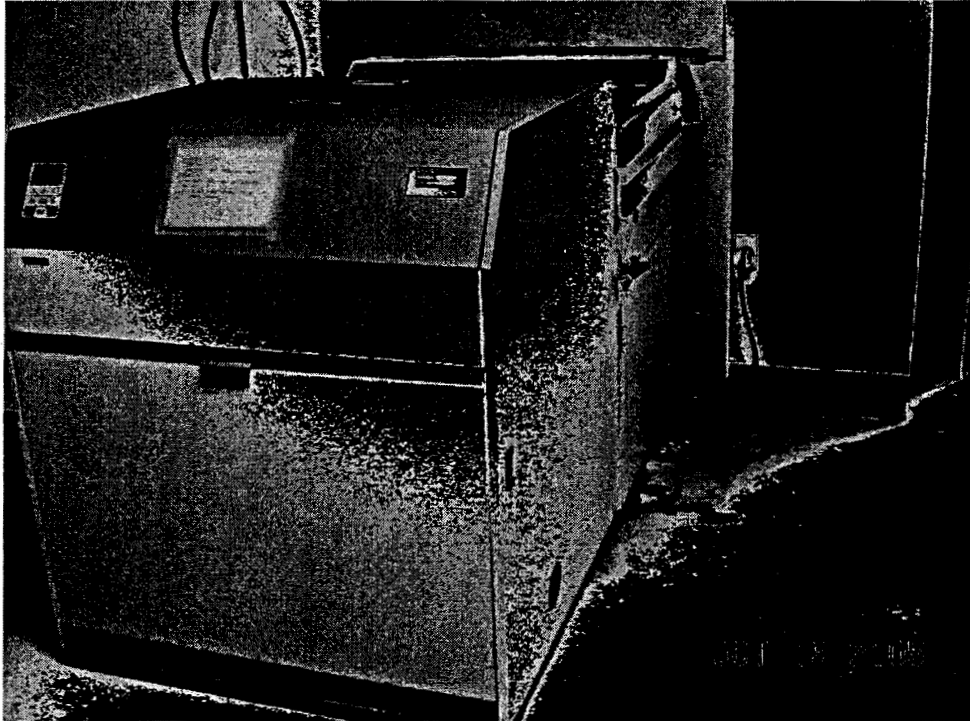
462

The print shop developer, the waste developer is discharge directly to the sanitary. Reportedly , this waste does not contain regulated quantities of silver.

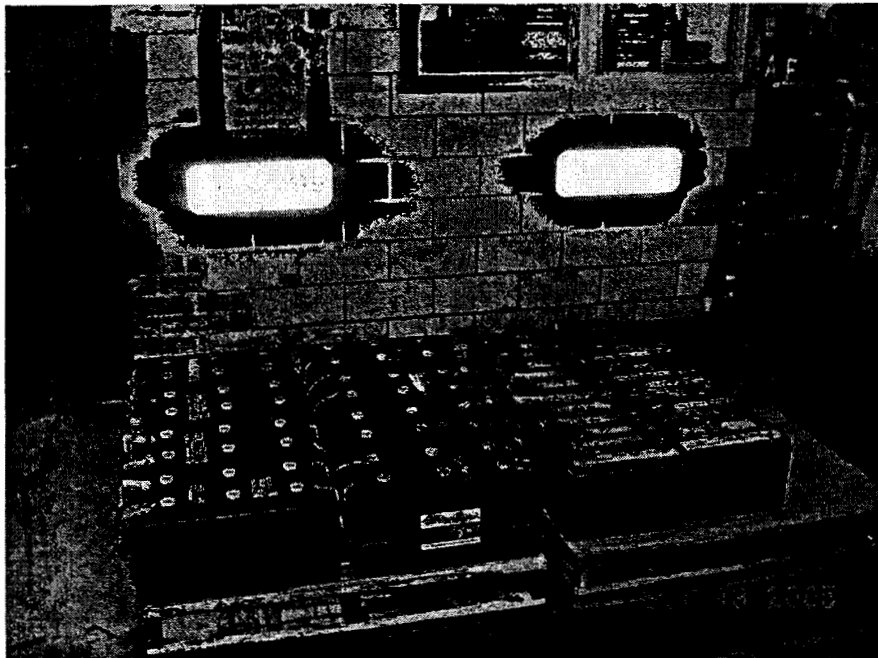
477

Bus battery storage, the batteries are recycled.
